**DOT/FAA/AR-99/7**

# **Small-Engine Uncontained Debris Analysis**

February 1999

Final Report

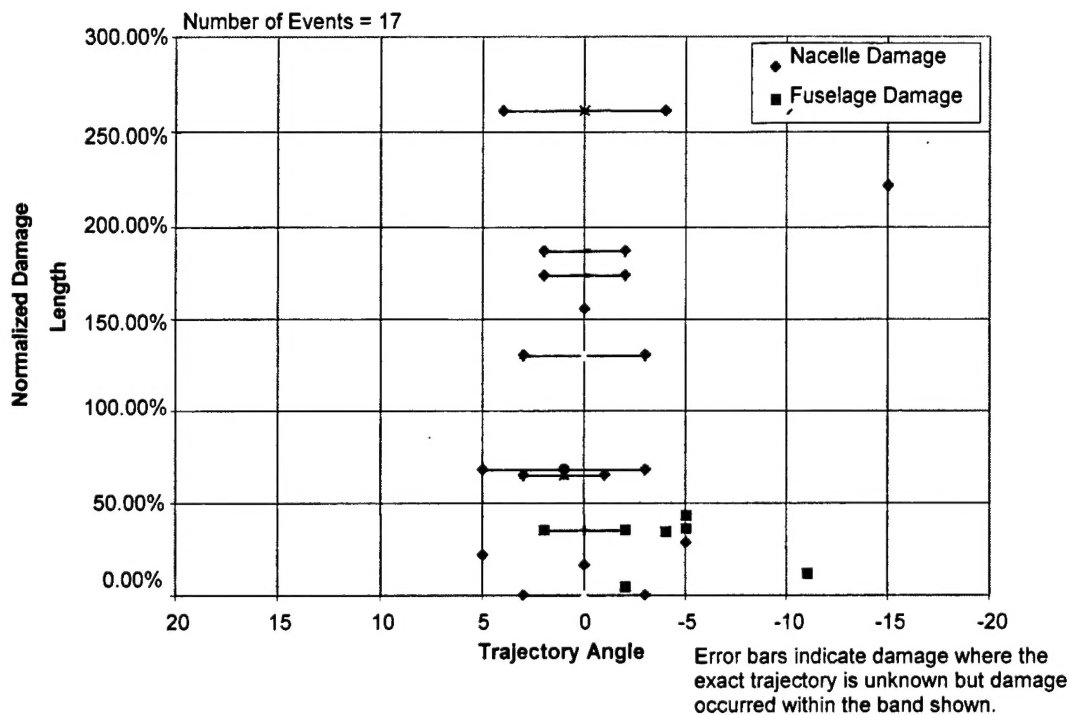
FIGURE 1. ALL EVENTS TRAJECTORY PLOT

An overview of the available trajectory data is shown in figure 1. Data is shown for nacelle and fuselage damage. Trajectory angles are positive for forward trajectories and negative for aft trajectories. It is evident that nacelle damage is typically significantly larger than the failed component dimensions.

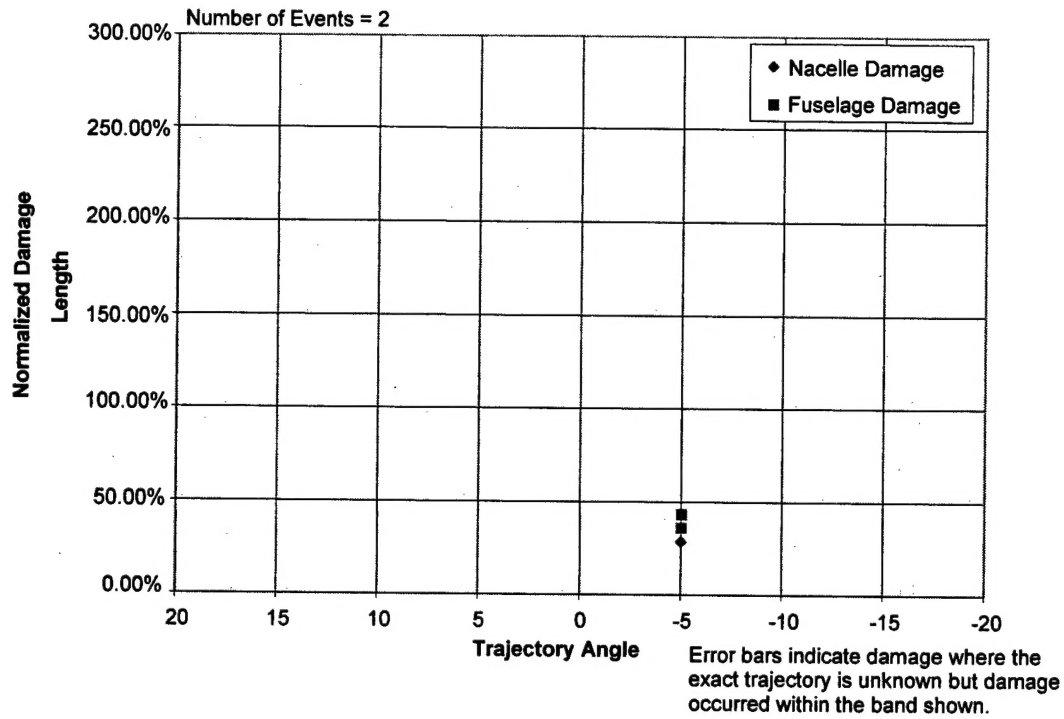
FIGURE 2. COMPRESSOR EVENTS TRAJECTORY PLOT

**COMPRESSOR FAILURES.** There are five incidents with compressor failures. Three of the events were rim failures with one blade and disk failure respectively. Damage and trajectory data are provided for two of the events (figure 2). Of these two events, one was a disk event (figure 3) and one was a rim event (figure 4). All of the damage was reported at a  $-5$ -degree trajectory angle. The damage ratio is less than 50% of the disk diameter in all cases.

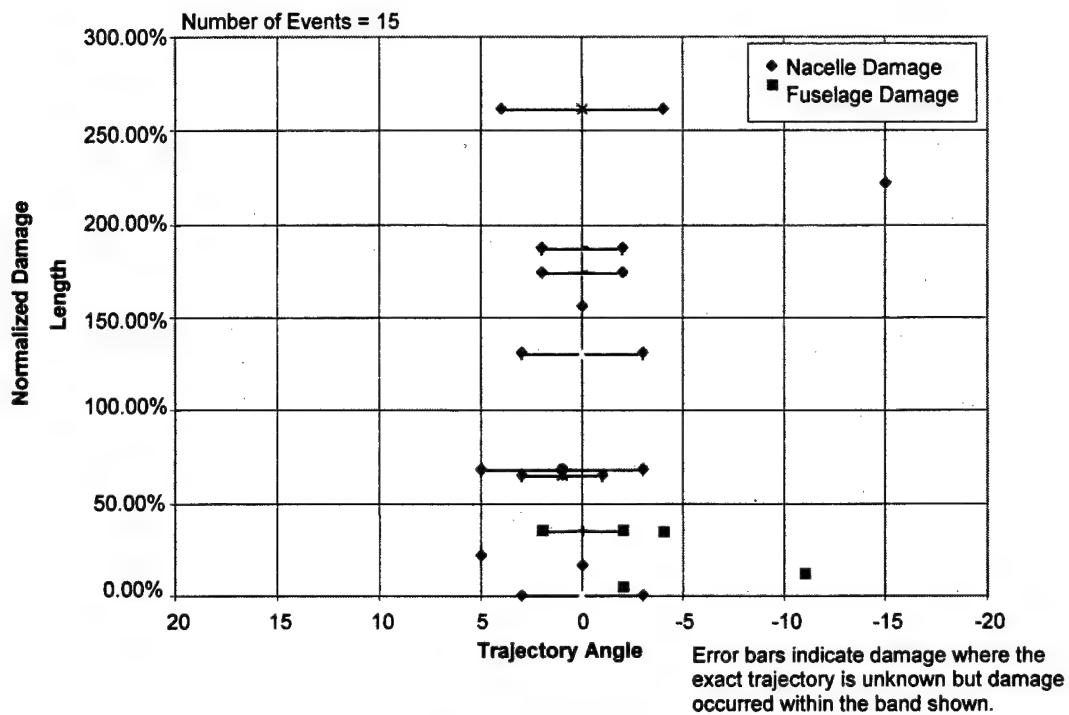
FIGURE 5. TURBINE EVENT TRAJECTORY PLOT

**TURBINE FAILURES.** The majority of the incidents reported were from turbine failures, 34 uncontained events. Fifteen were turbine rim failures, and 13 were turbine disk failures. Of the 34 events, only 15 reports contain trajectory and damage data (figure 5). Seven of these reports include the general forward and aft spread angle that the debris exited the nacelle. The majority of the data falls within a  $\pm 5$ -degree spread angle. Damage to the nacelle has been reported as large as 2.60 times larger than the disk diameter. Fuselage damage was reported as less than 50% of the disk diameter in all cases. Trajectories for the debris damage to the nacelle ranged from 5 degrees forward to -15 degrees aft. Damage to the fuselage ranged from 2 degrees forward to -11 degrees aft.

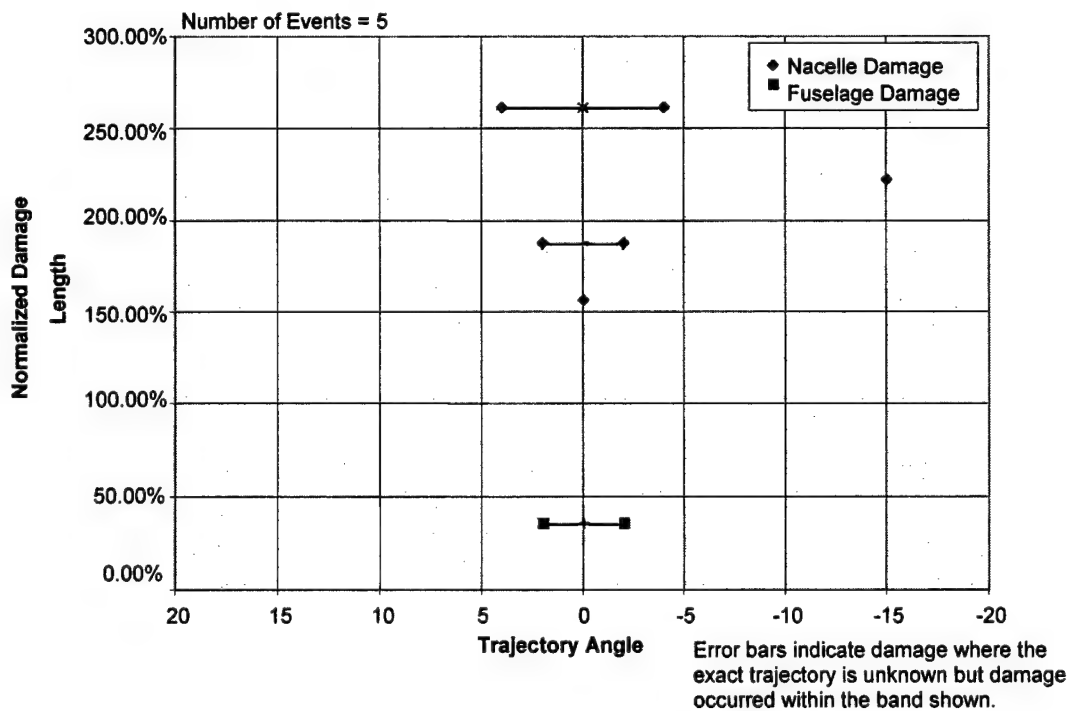
FIGURE 6. TURBINE DISK EVENT TRAJECTORY PLOT

Five turbine disk events were recorded with only one reporting damage to the aircraft fuselage (figure 6). In this case, damage was reported with a trajectory spread of  $\pm 2$  degrees. The trajectory spread for the turbine disk fragments is  $\pm 4$  degrees with an outlying point located at -15 degrees.
